26 August 2020

**Subject: Gas Monitoring and Control System Restoration Completion Letter –
Response to Additional Comments from DTSC
Genentech Building 48
645 East Grand Avenue
South San Francisco, California 94080
Langan Project No. 731677307**

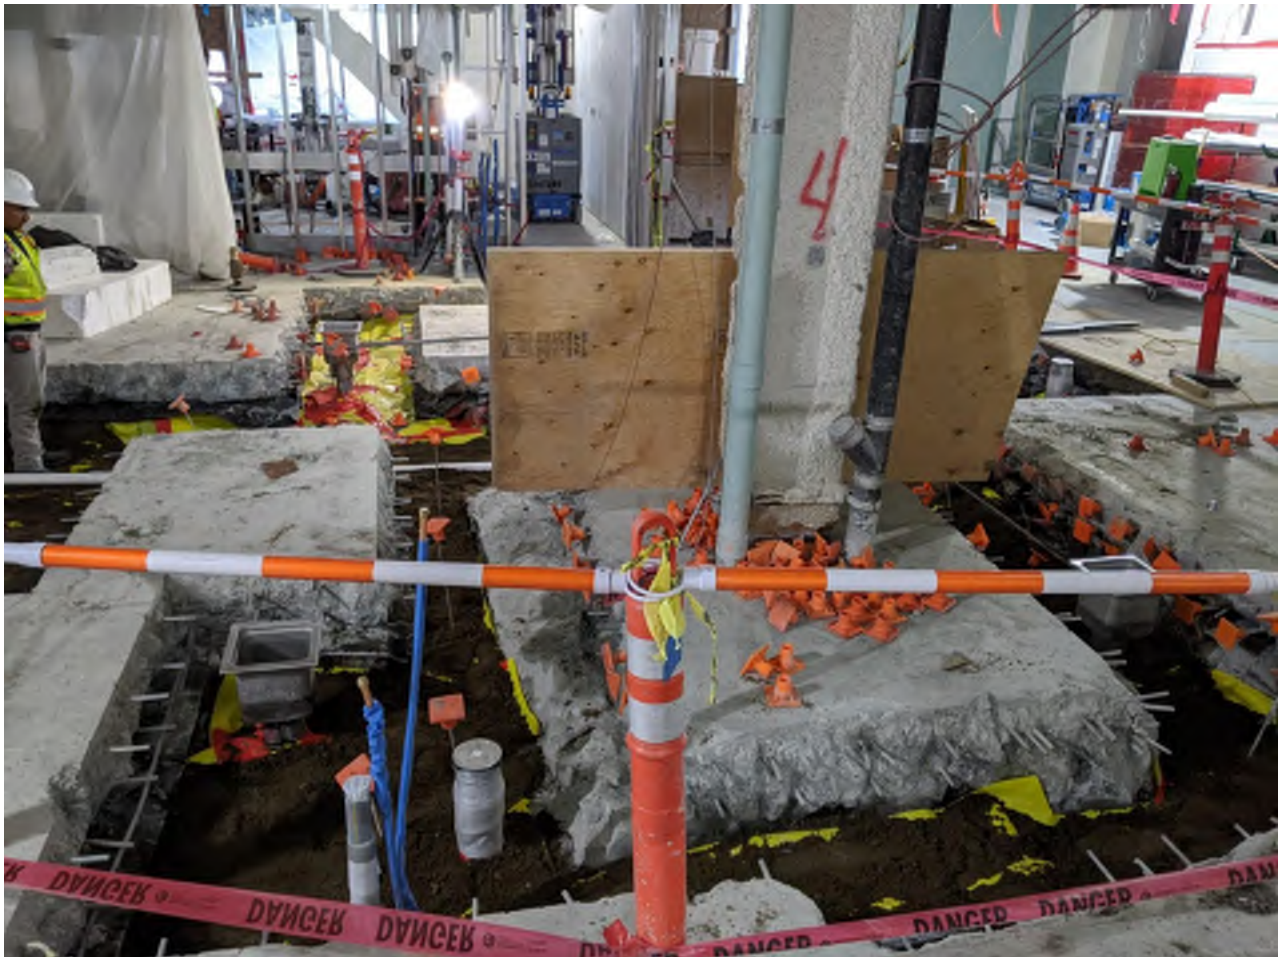
Photo 1: Phase 2 excavation area within ~~basement of~~ B48 (facing north).

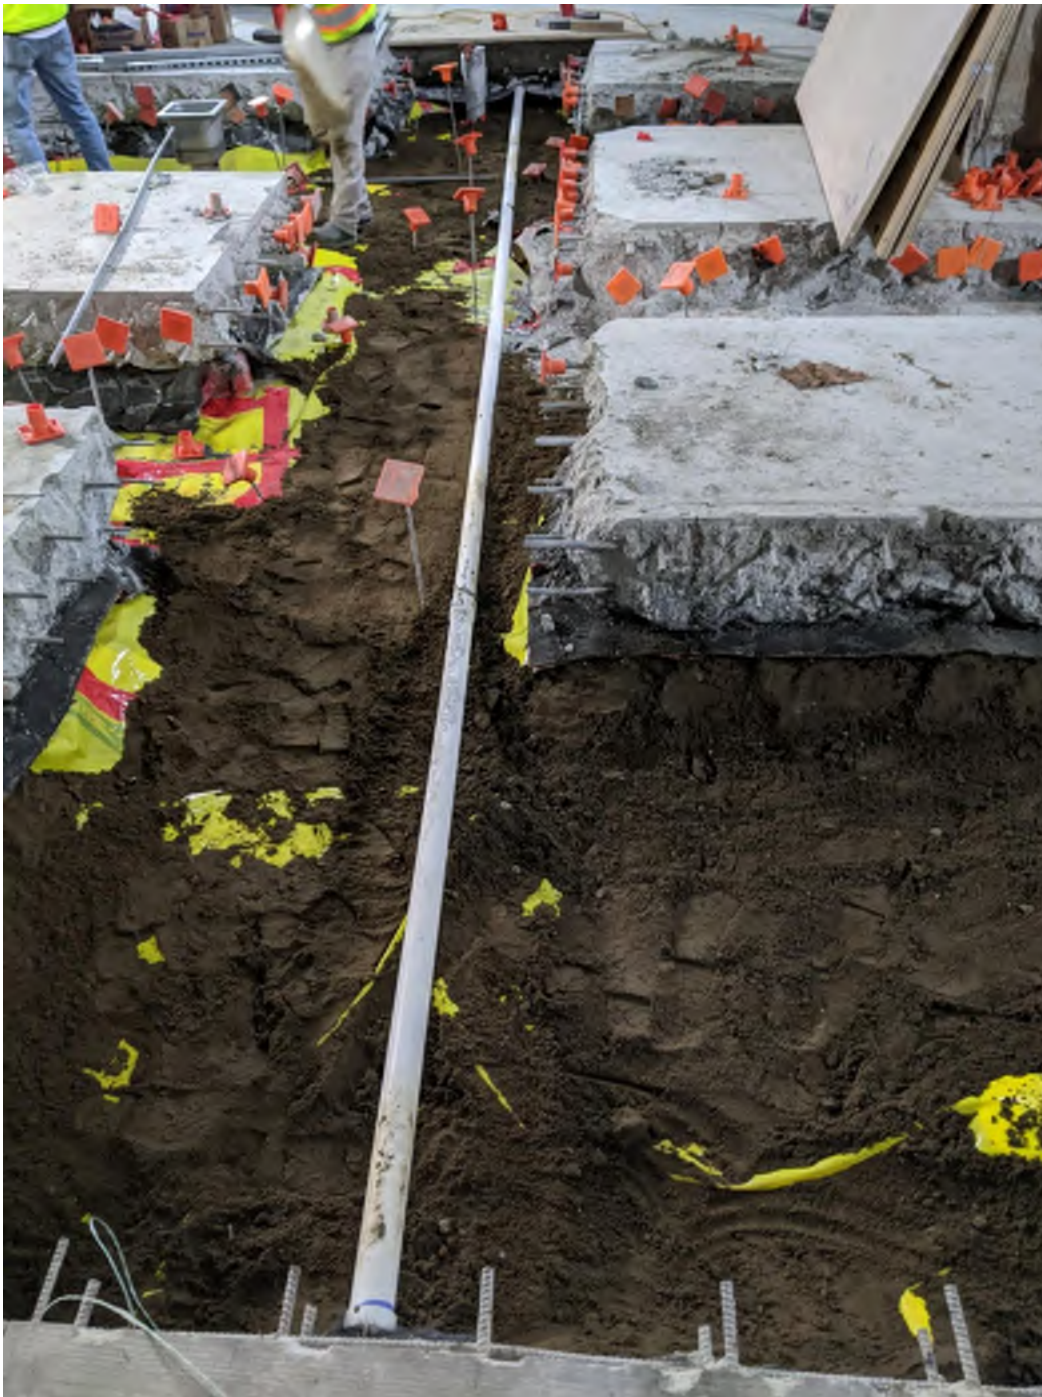
Photo 2: Fully repaired 2" PVC gas extraction pipe (facing east).

1340 Pipe repairs complete. The pipes were repaired to manufacturer specifications.

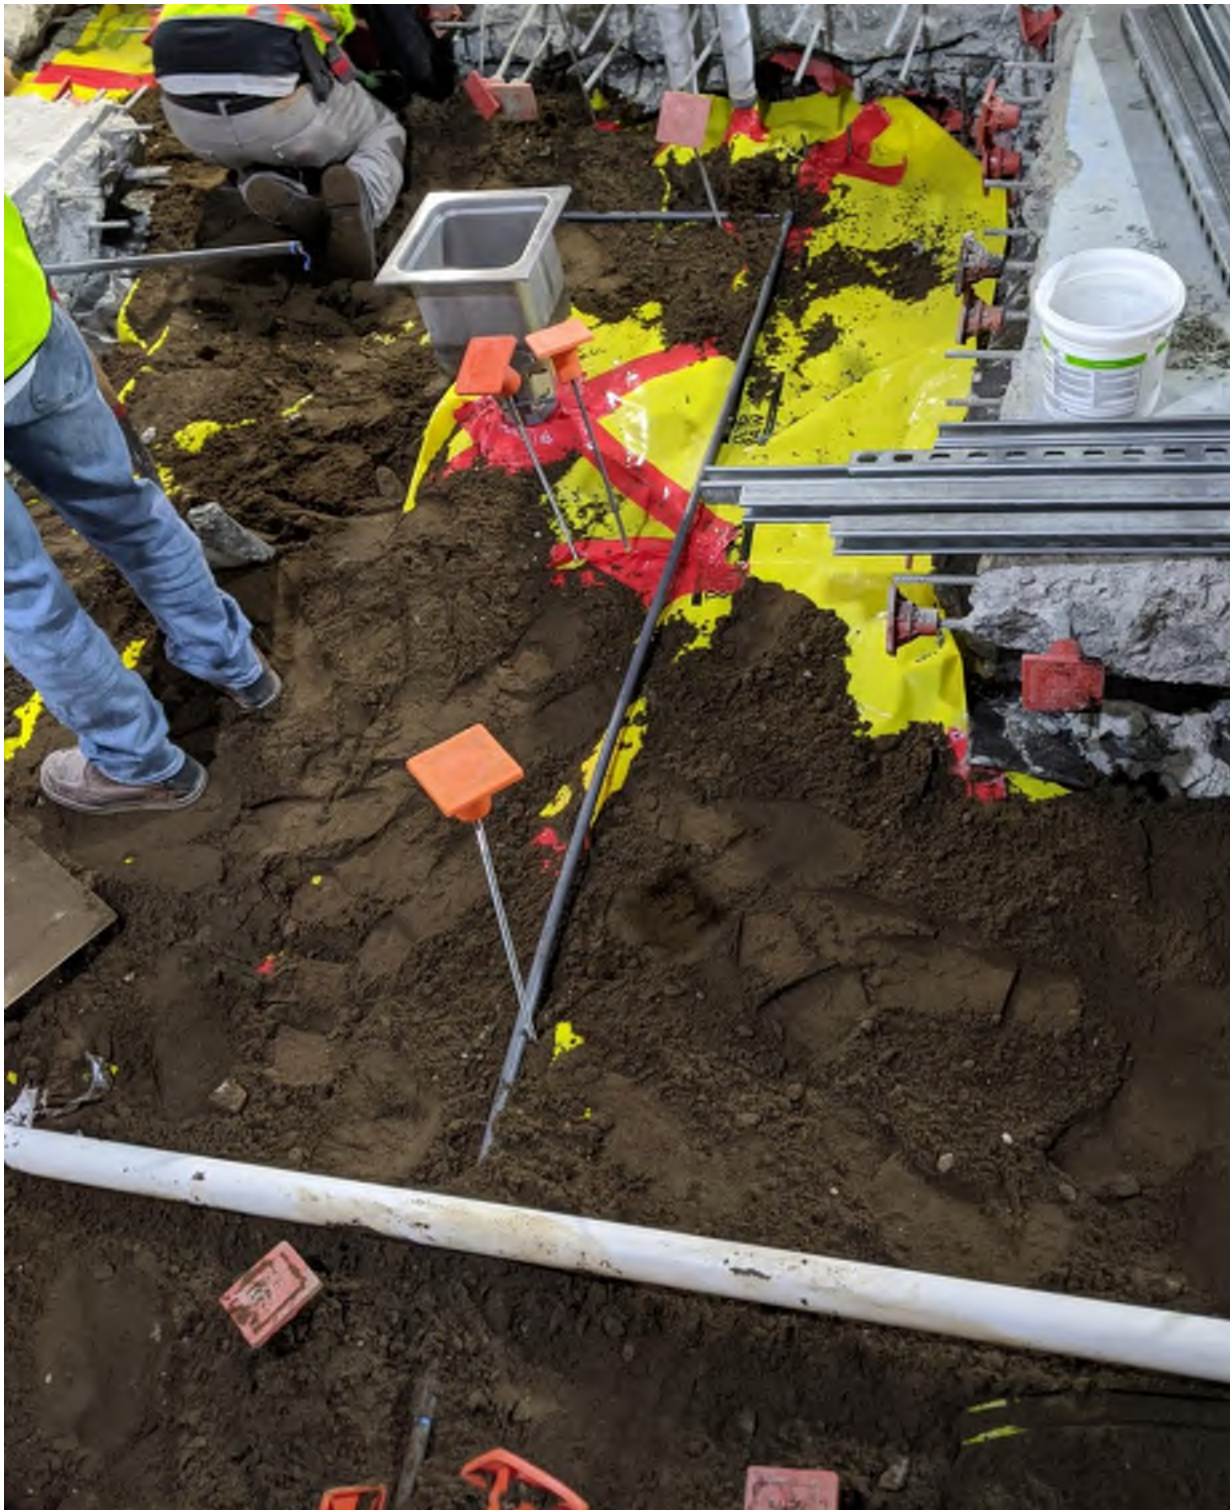
Photo 3: Fully repaired 1/2" solid gas monitoring pipe (facing north).

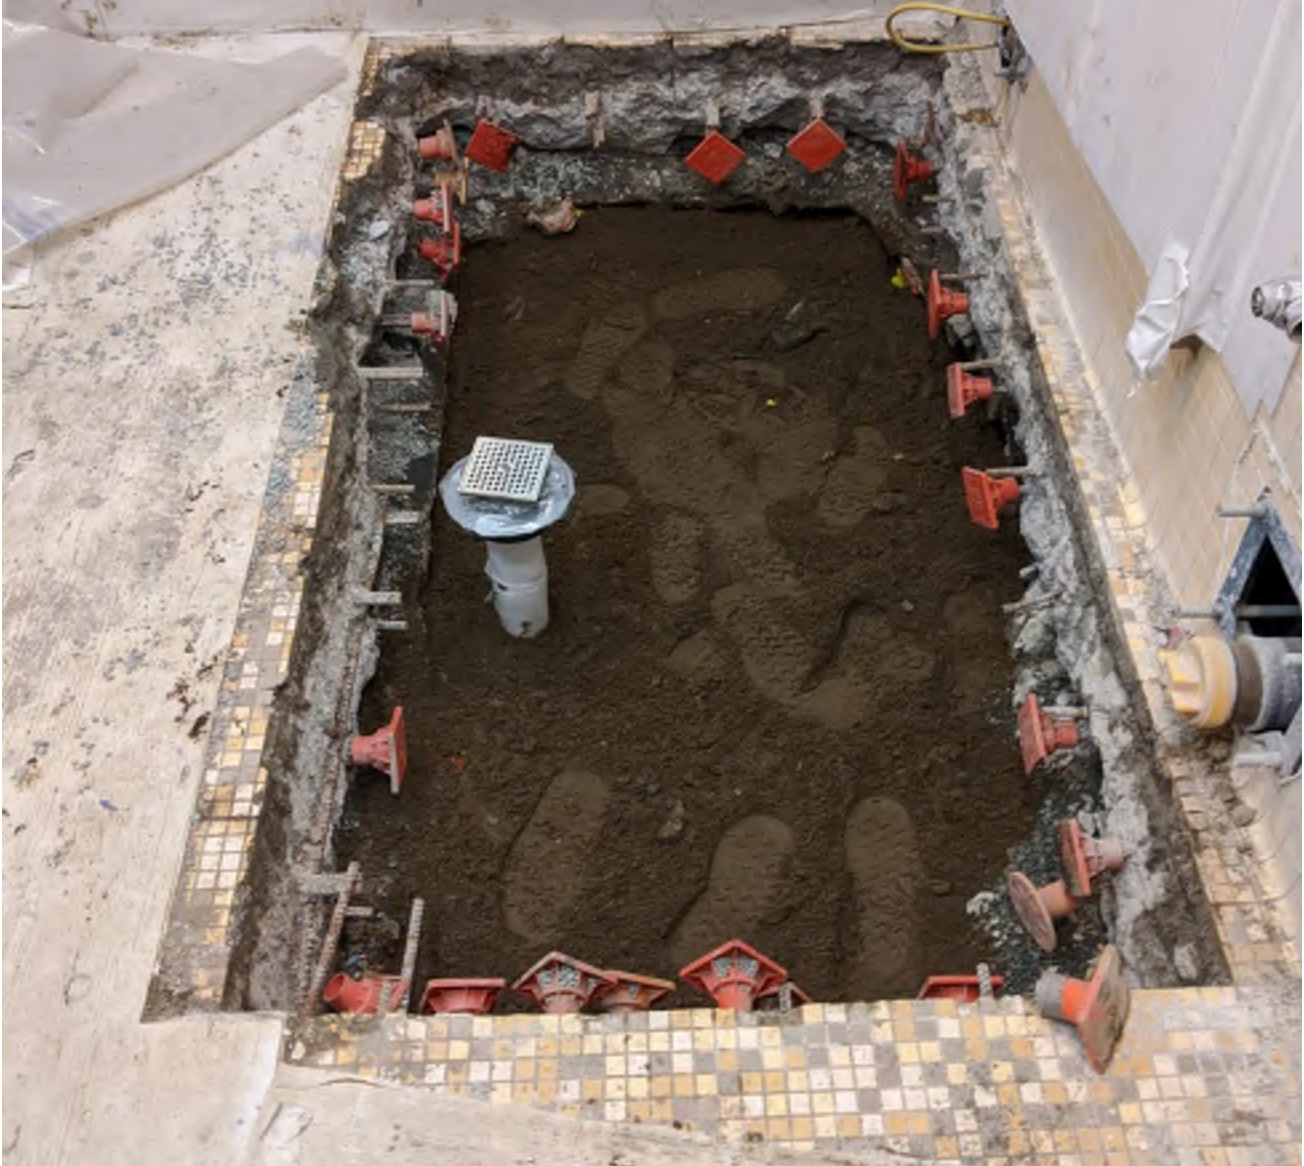
Photograph 4: View of small excavation area within men's bathroom (facing west).

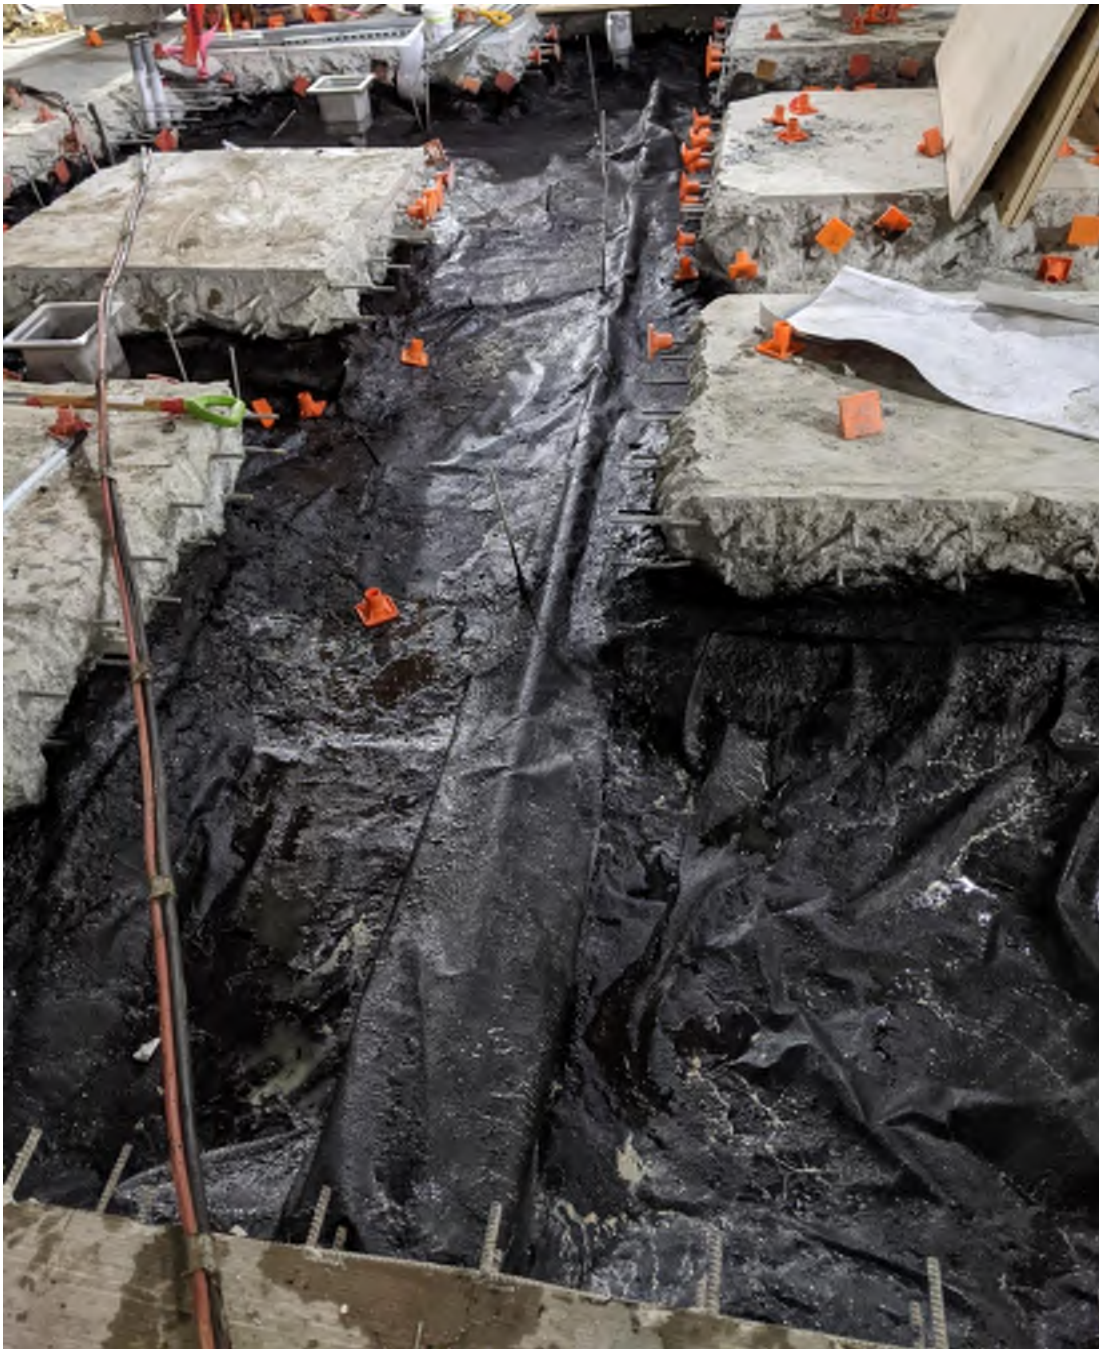
Photograph 5: View of GMCS repair over 2" PVC gas extraction pipe (facing east).

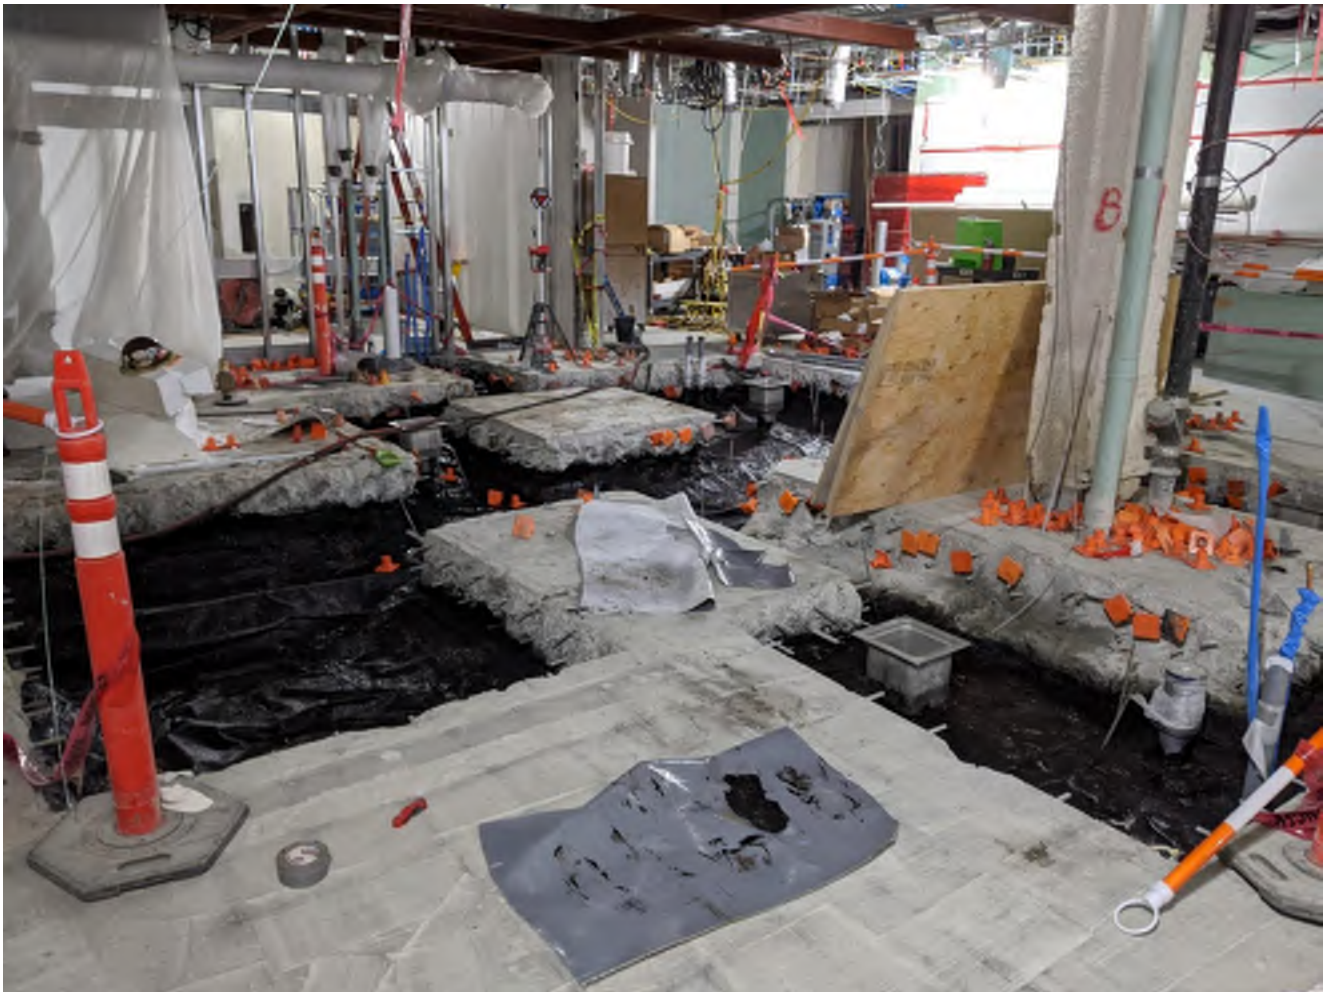
Photograph 6: View of complete Phase 2 excavation GMCS repair (facing northwest).

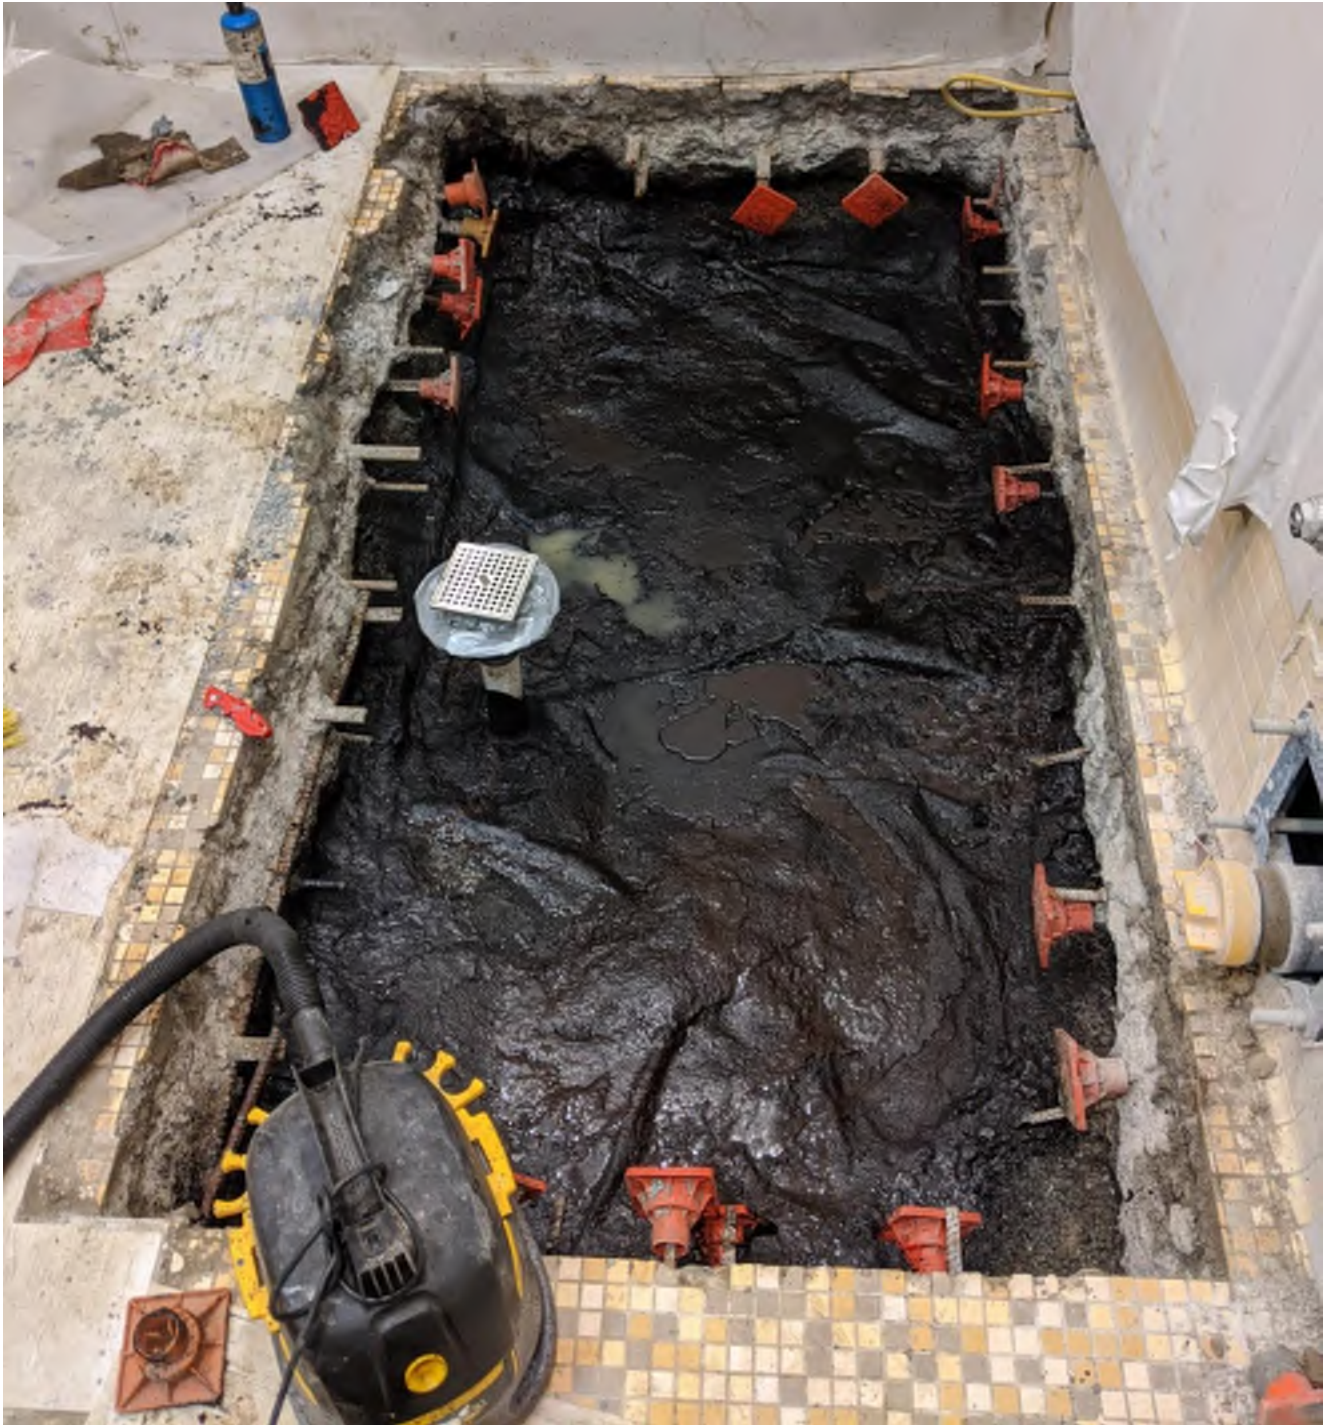
Photograph 7: View of complete GMCS repair within men's bathroom (facing west)

1910 Repair of GMCS cut in bathroom excavation begins.

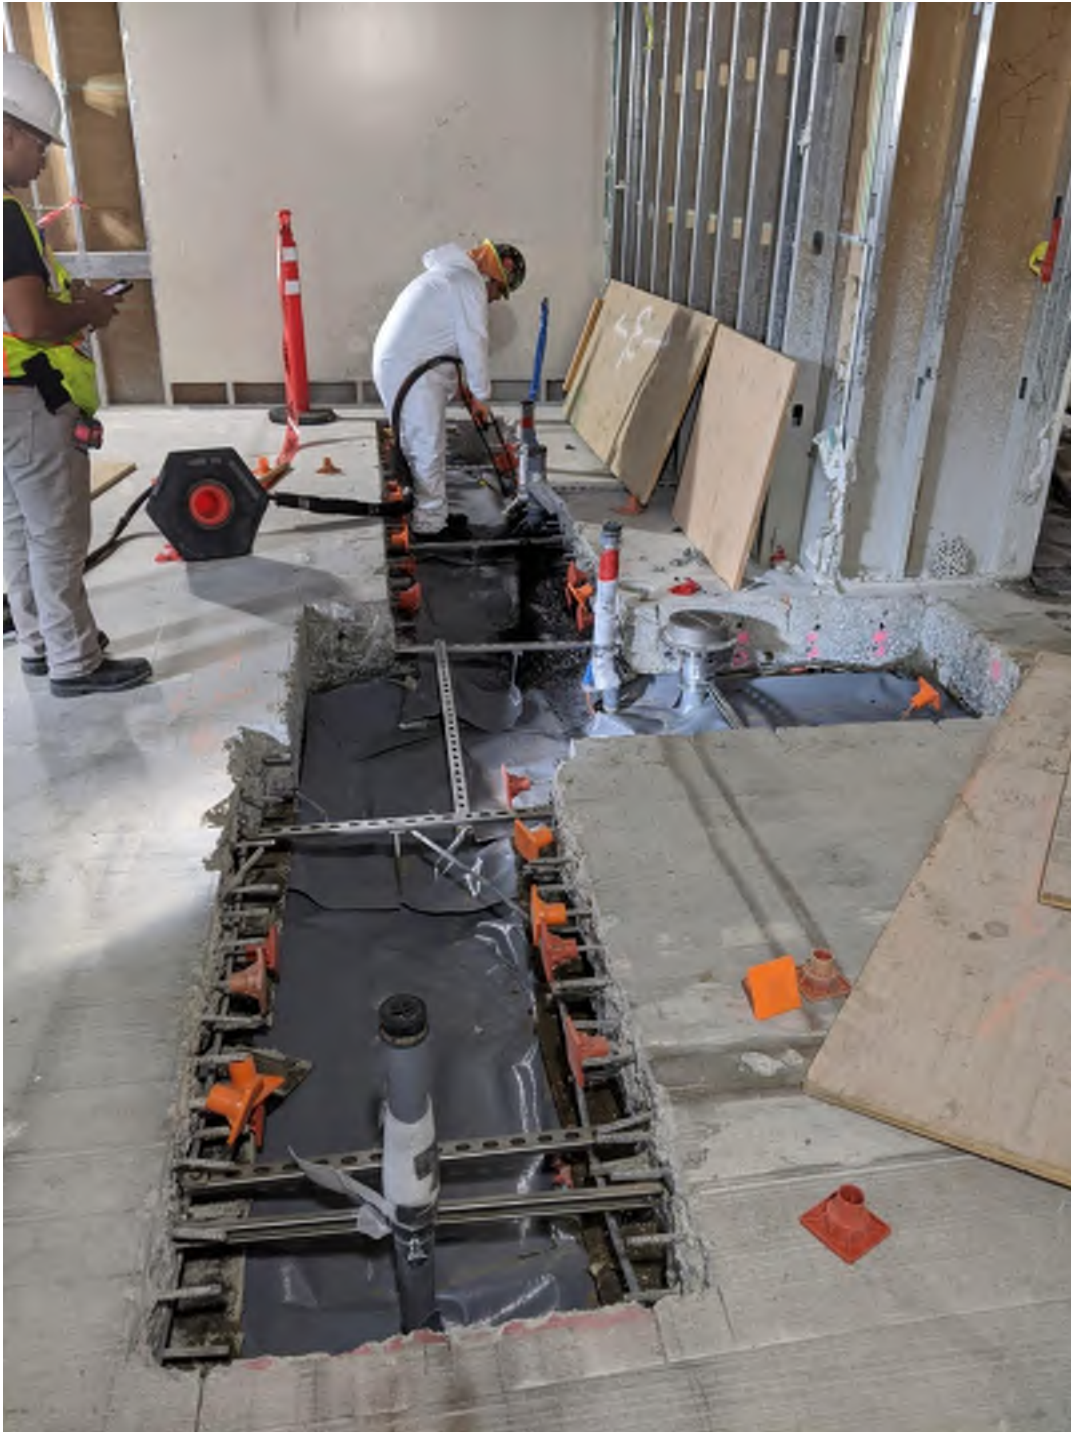
Photo 1: North Tower GMCS repair work underway near loading dock door (facing west).

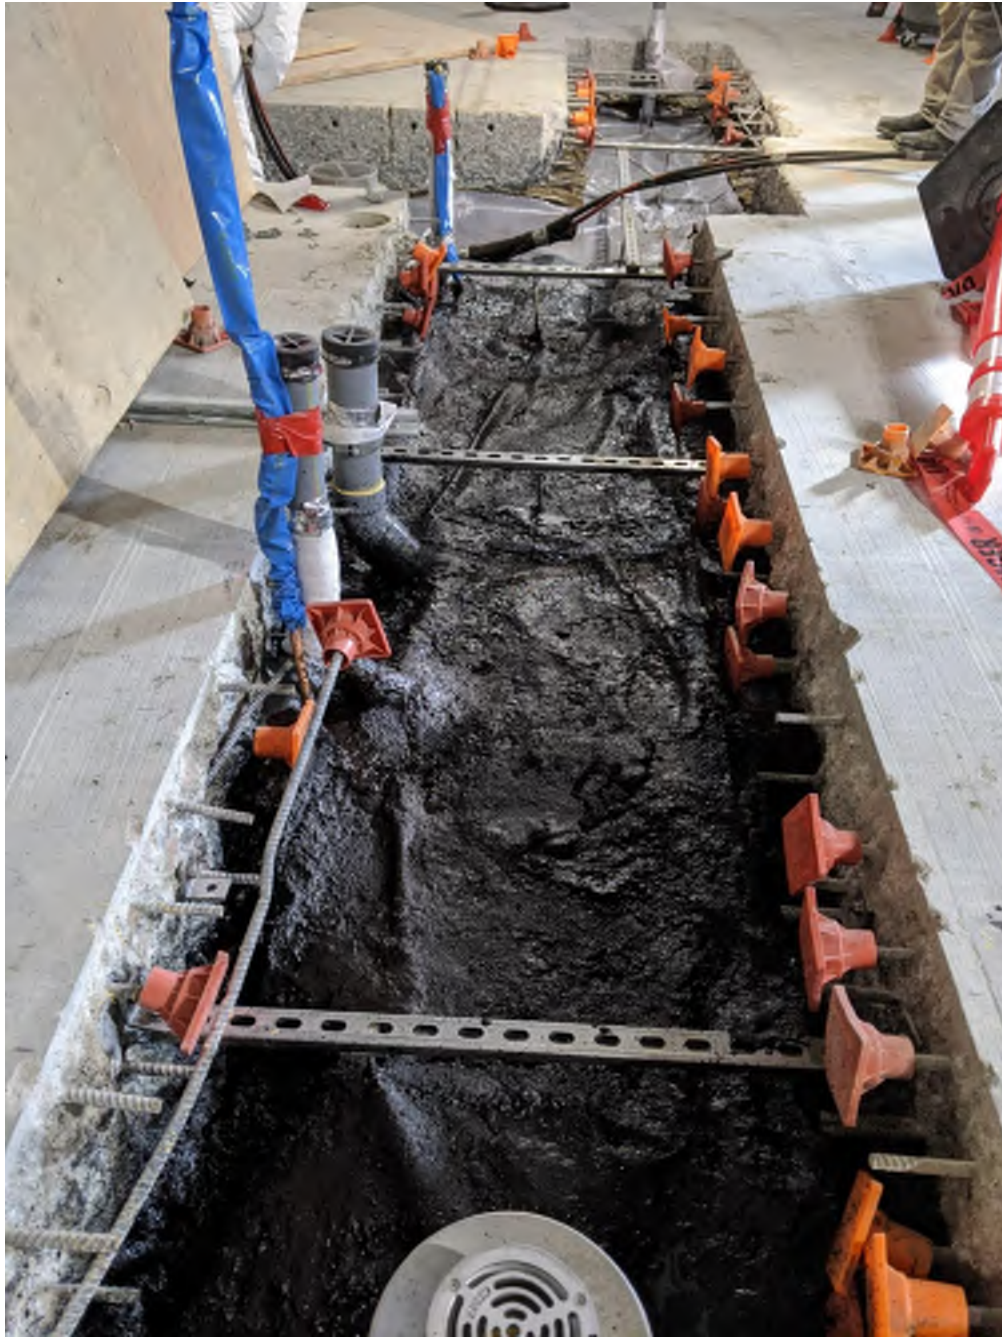
Photo 2: Progress of patching shown in Photo 1 (facing east).

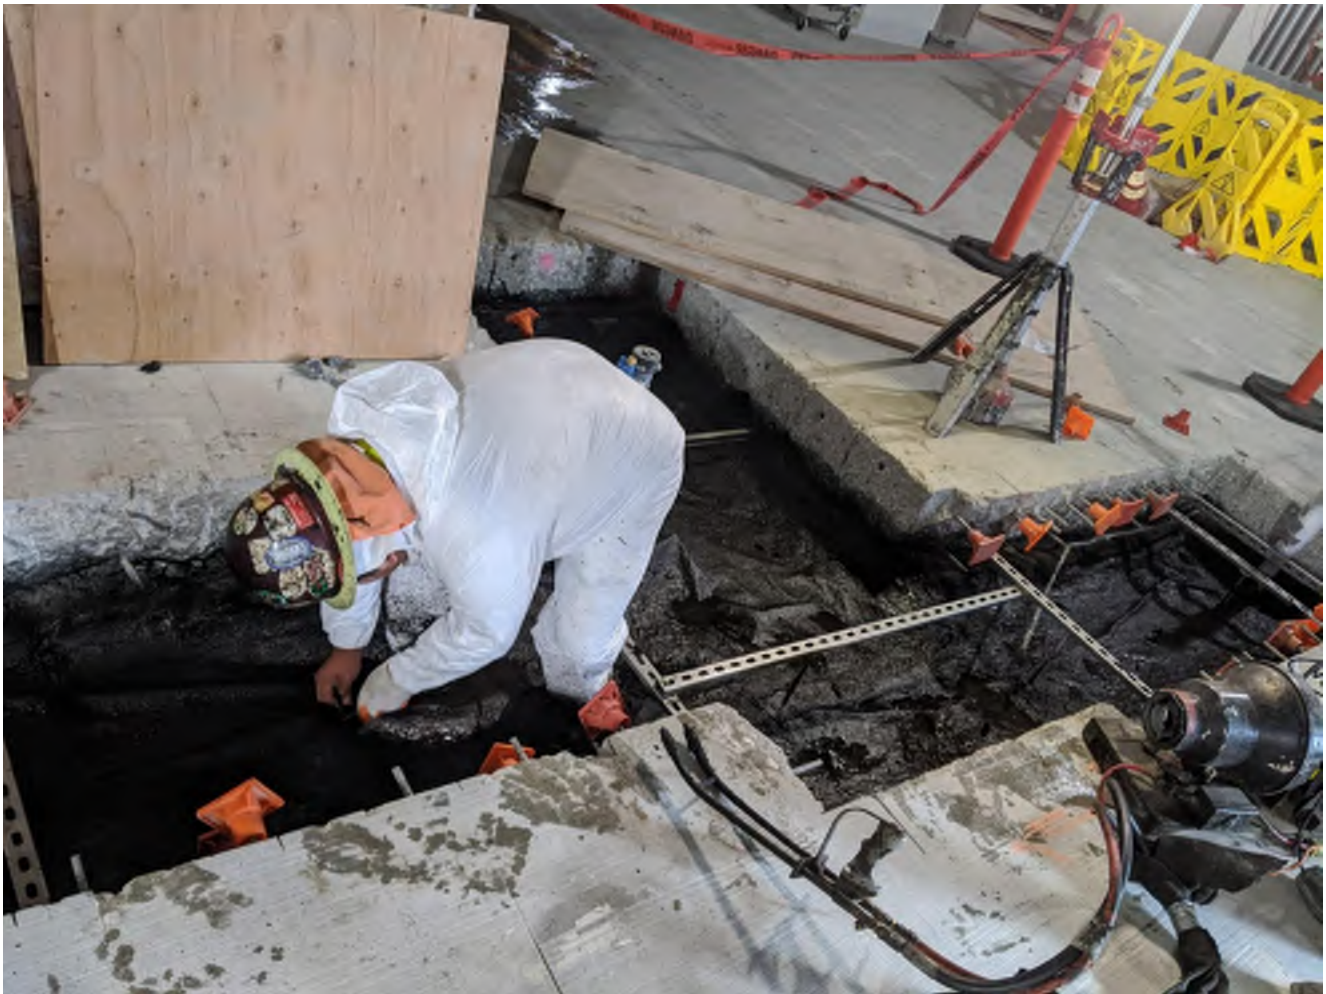
Photo 3: Progress of patching shown in Photo 1 (facing northeast).

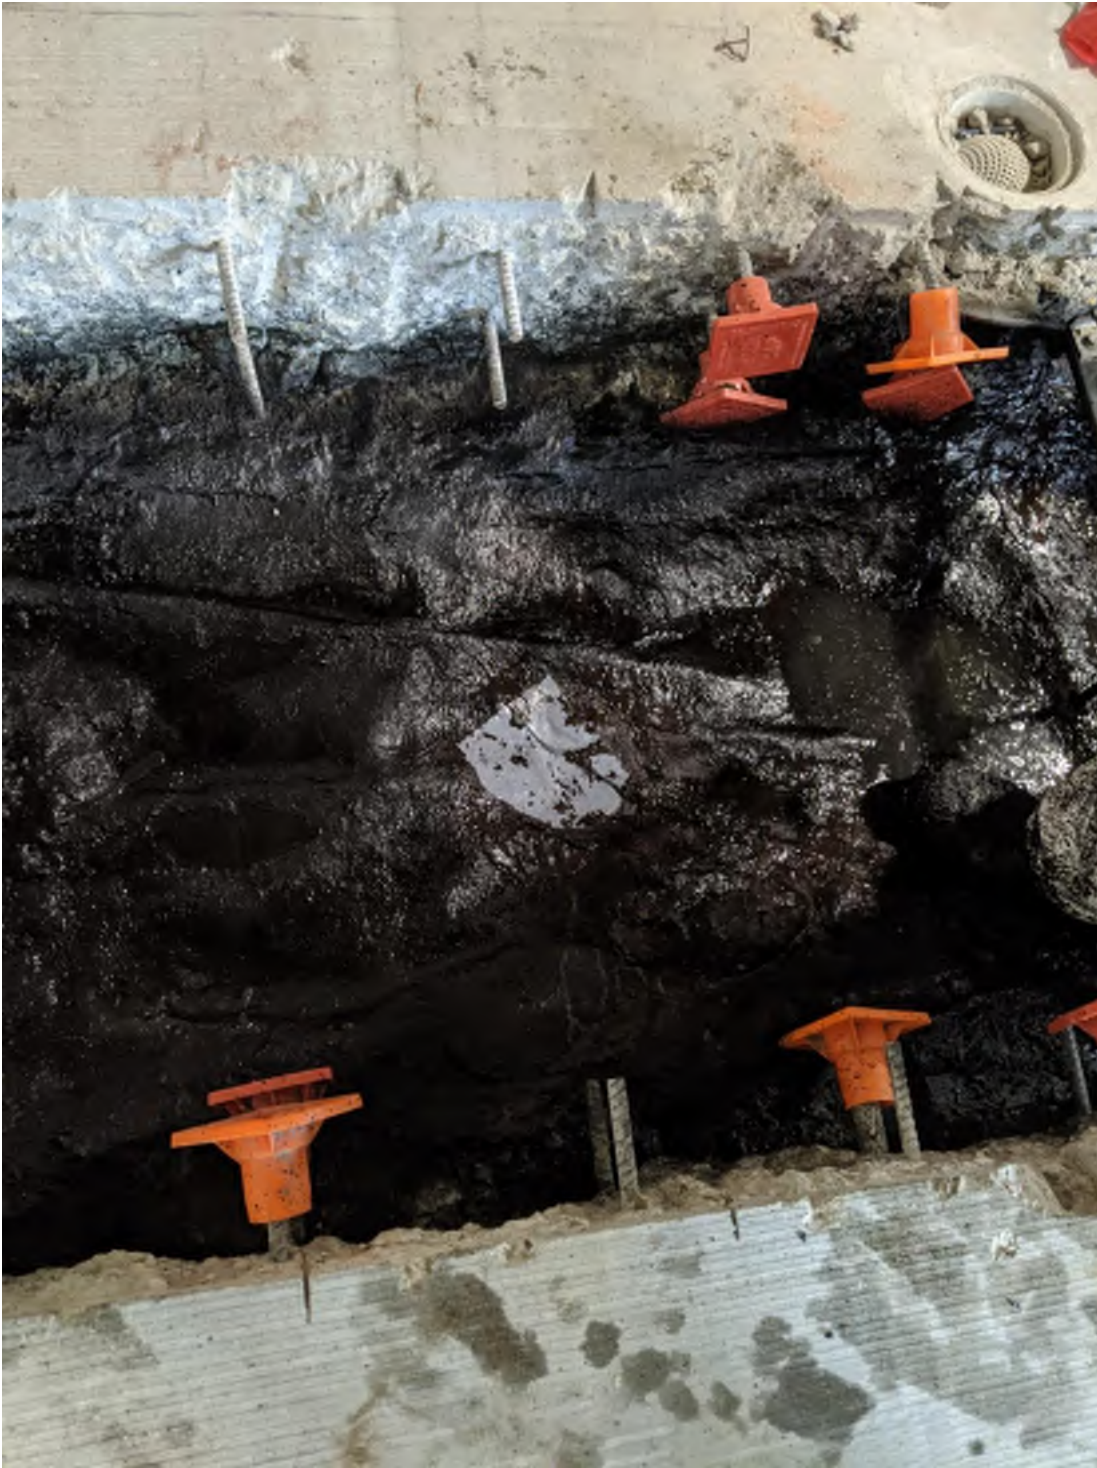
Photo 4: Repair of area cut for smoke testing (facing north).

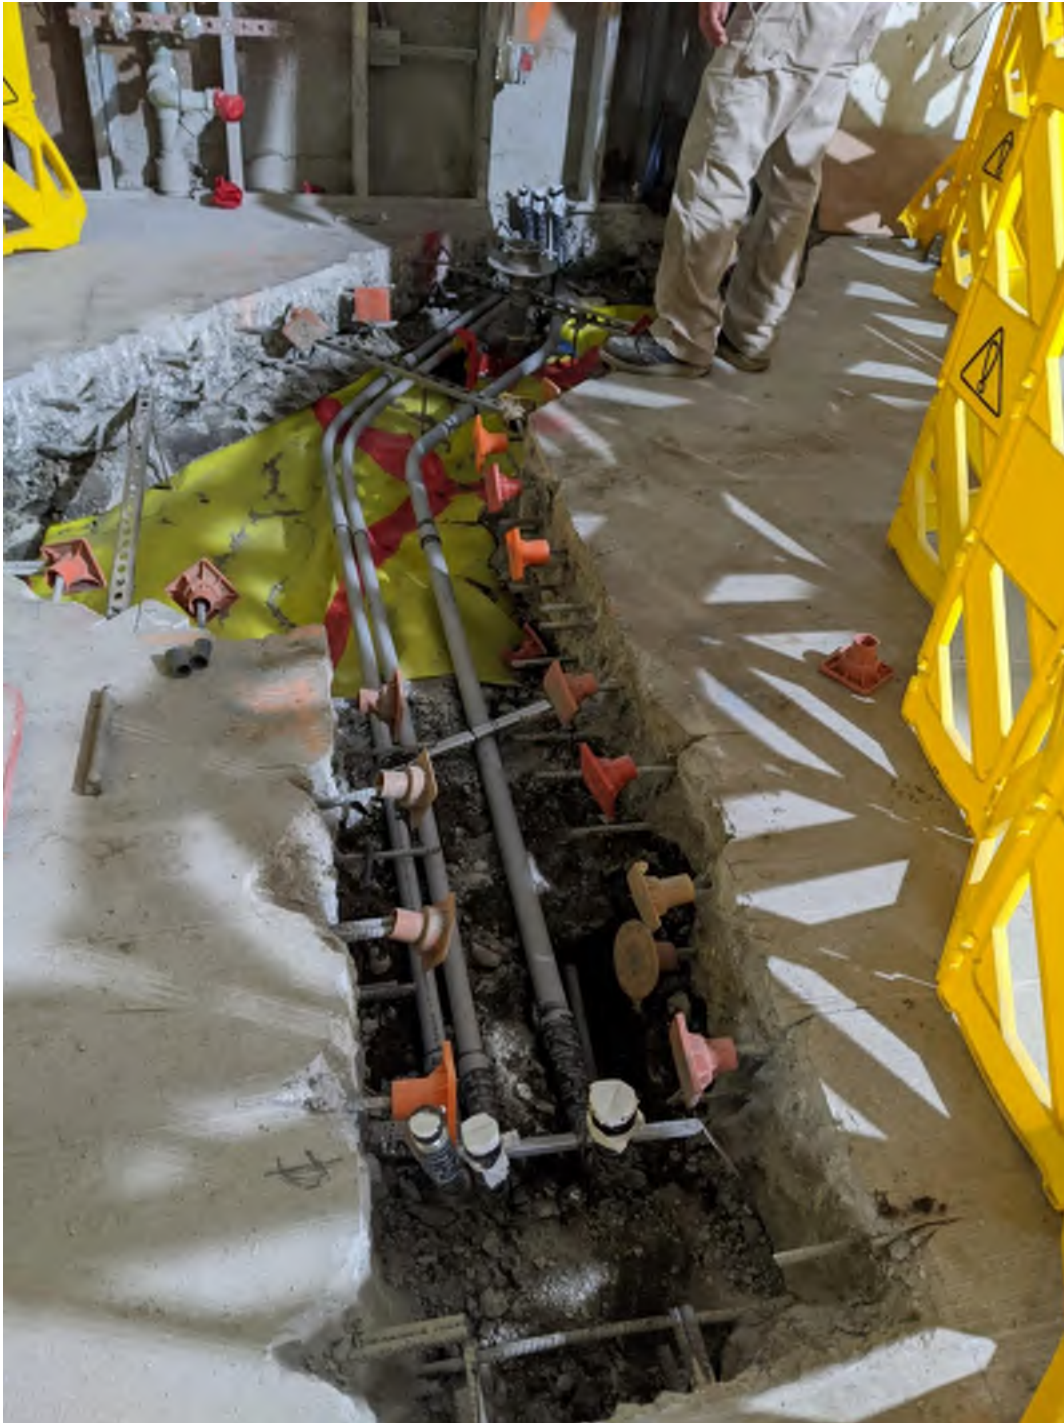
Photo 1: Preparation for EPRO application to north western most repair section (facing west).

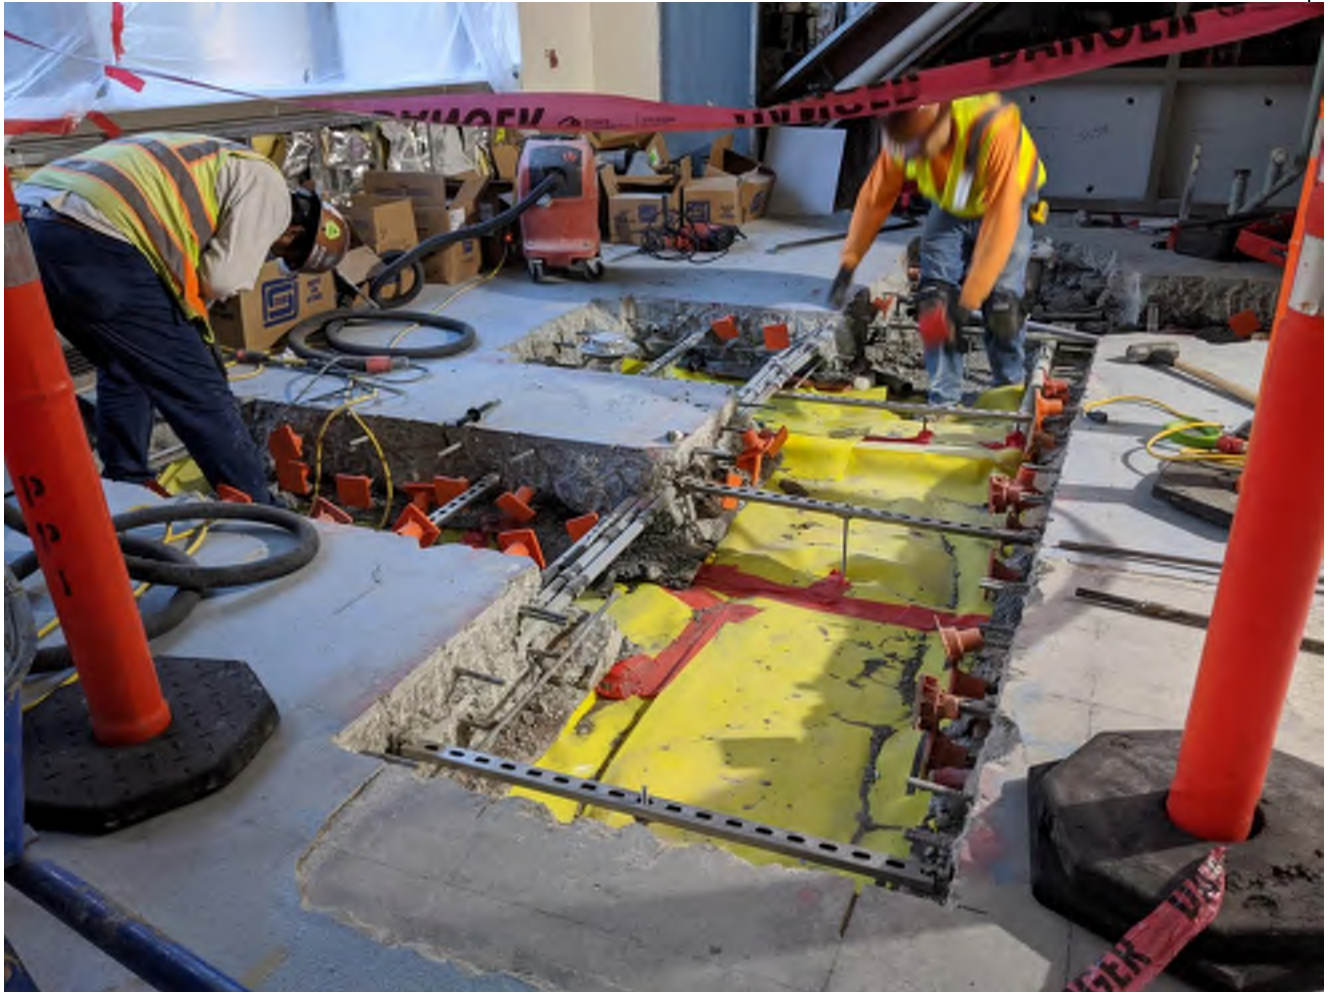
Photo 2: Preparation for EPRO application on north eastern-most repair section (facing east).

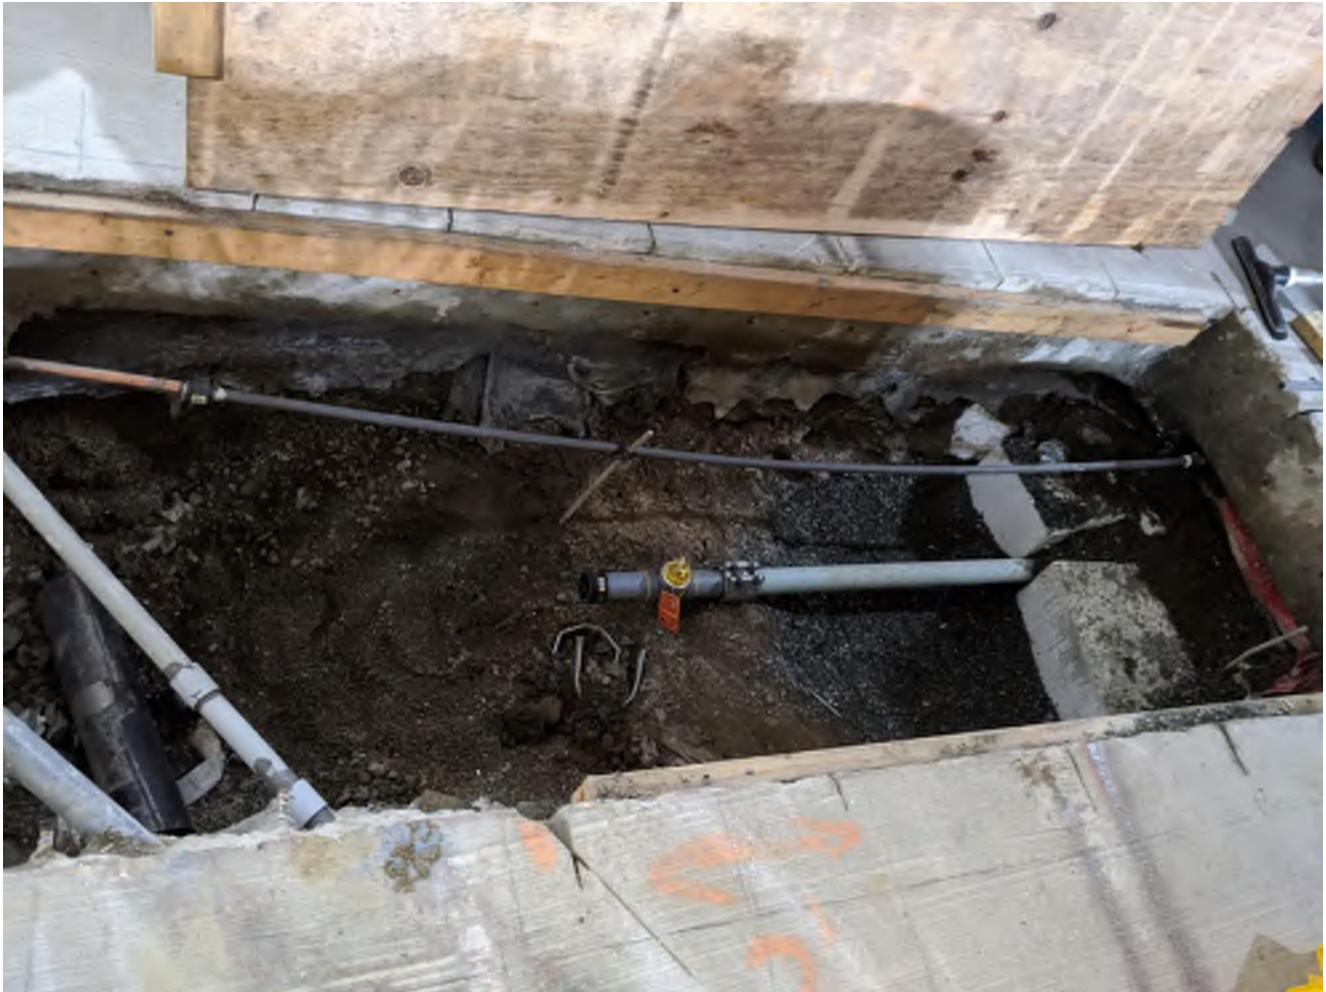
Photo 3: Progress of 1/2" solid gas monitoring pipe replacement (facing south).

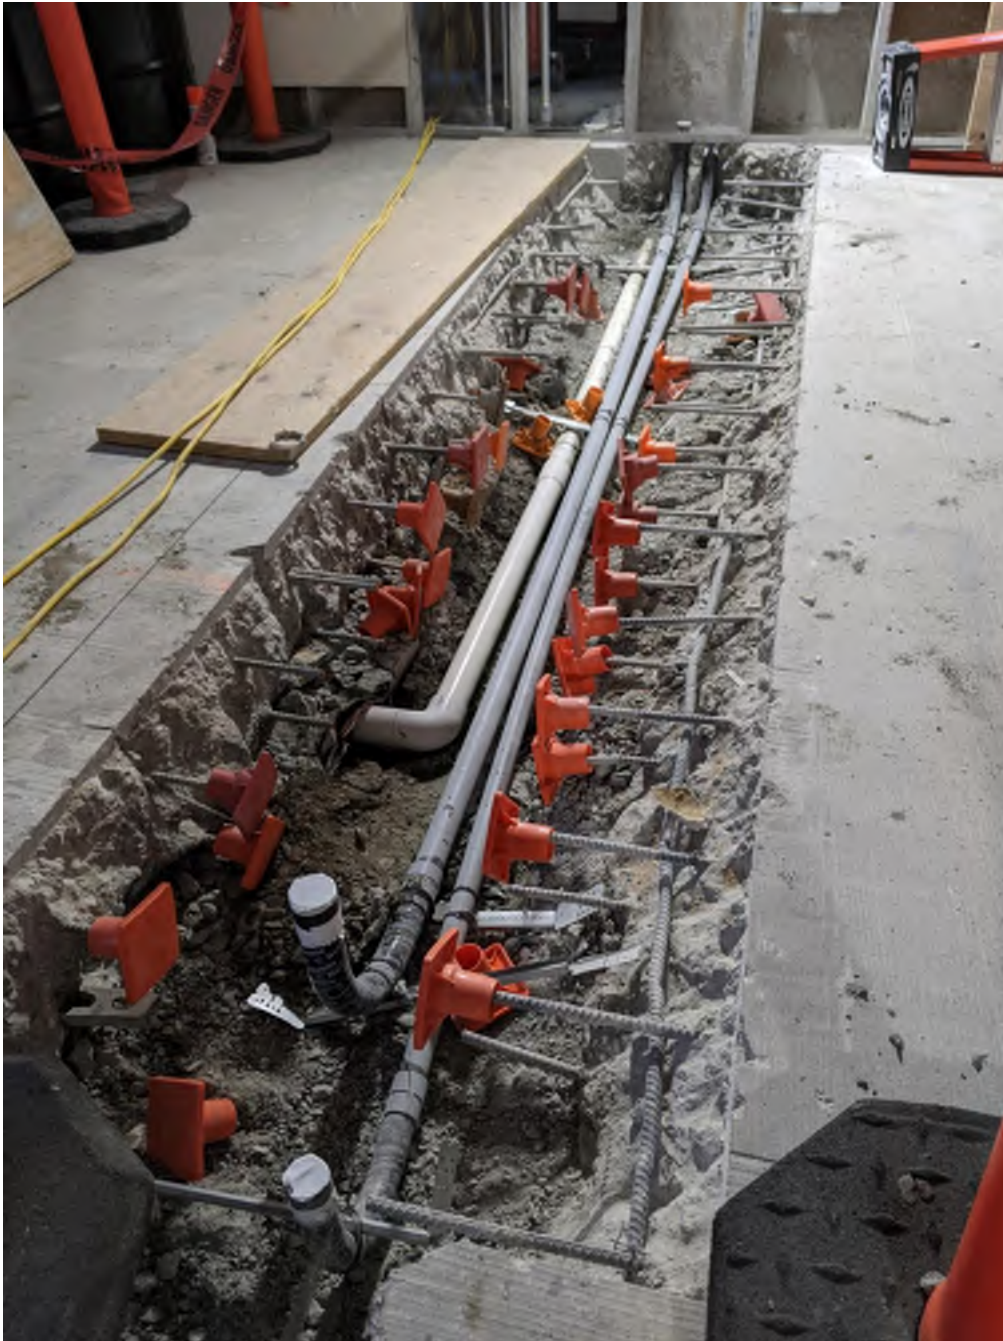
Photo 4: Preparation for GMCS repair to center trenching area (facing north).
